TECHNICAL INFO

Renault Scenic/Grand Scenic II

● PROBLEM

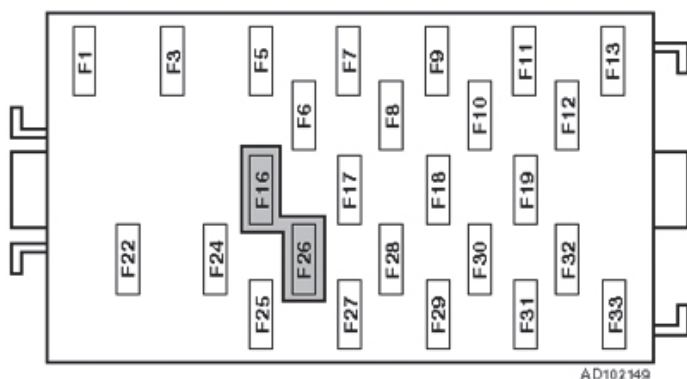
When starting the engine the ESP warning light illuminates. Error code saved: DEF 74 (concerning the steering angle sensor).

The battery voltage is too low when starting the engine.

Remove the fuse box from the instrument panel. Pull the fuse F16 ABS and the back-up fuse F26. Interconnect the slots F16 and F26 with the shunt.

Put the fuses on the shunt. Check the ESP warning light for function.

- With the ignition on the ESP warning light illuminates.
- Operating the starter the ESP warning light goes out.
- Engine starts, release car ignition key
- The ESP warning light illuminates for a period of 3 s before going out.
