THE **BREMBO** GUIDE
TO **BRAKE DISC**
ASSEMBLY AND
MAINTENANCE

Curno, September 15, 1997

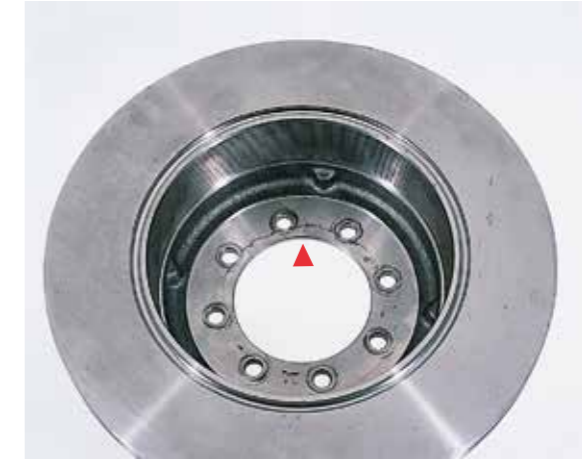
2.1.1 INCORRECT TIGHTENING

Description of defect: Formation of cracks on the carrier surface in contact with the hub. This is due to incorrect tightening during fitting. The tightening sequence has not been followed and torque is insufficient. Failure to follow the recommended sequence and tightening torque can cause distortion of the carrier mounting surface even when there are no visible cracks.

Consequences: Distortion of the carrier mounting surface causes vibrations that can be felt immediately after fitting when the brake pedal is pressed.

Advice: Fit another disc, following the recommended sequence and tightening torque.

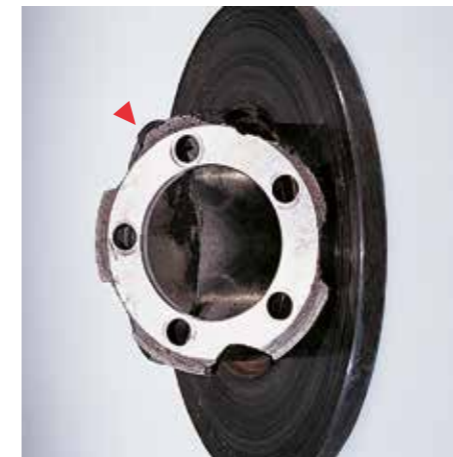
2.1.2 FAILURE TO OBSERVE THE RECOMMENDED TIGHTENING TORQUE

Description of the defect: The carrier mounting surface breaks away from the rest of the disc. There are clear signs of excessive tightening, above all in the area of the two fixing holes. This is evidence of a failure to observe the recommended torque and sequence during tightening.

Consequences: Pronounced rasping noises and absence of braking torque.

Advice: Fit another disc, following the recommended sequence and tightening torque.

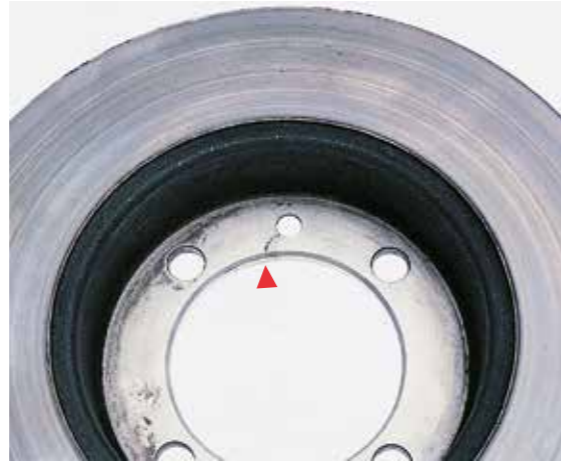
2.1.3 EXCESSIVE TIGHTENING OF THE POSITIONING BOLT

Description of the defect: The carrier mounting surface can easily distort when the disc positioning bolt is tightened too much. This excessive tightening can cause the mounting surface to break as can be seen in the photo.

Consequences: Run outing cannot be kept within an acceptable tolerance. Heavy vibrations occur during the very first kilometres following installation.

Advice: Tightening bolts are only intended to ensure that discs are positioned correctly. Do not tighten them excessively.

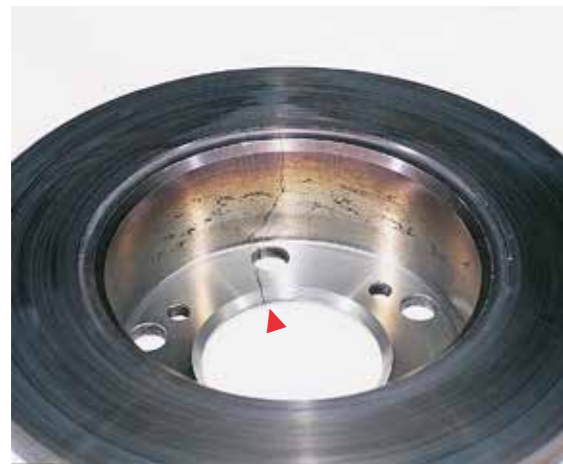
2.1.4 FITTING A DISC THAT DOES NOT CORRESPOND TO THE CAR

Formation of cracks on the carrier mounting surface. Signs of a poor match between the diameter of the disc centring and that of the hub.

Consequences: Disc contact with the wheel hub is incorrect. This defective installation will immediately cause vibrations due to excessive run outing.

Advice: Check catalogues to determine the correct disc reference: model, year of manufacture. Never force discs when fitting.

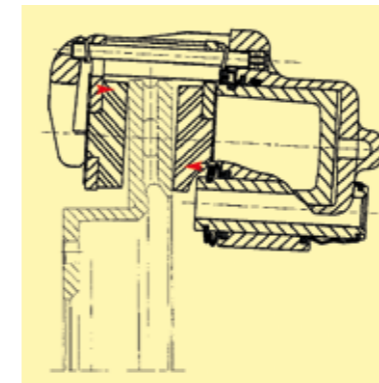
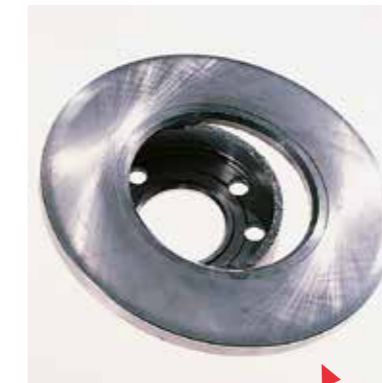
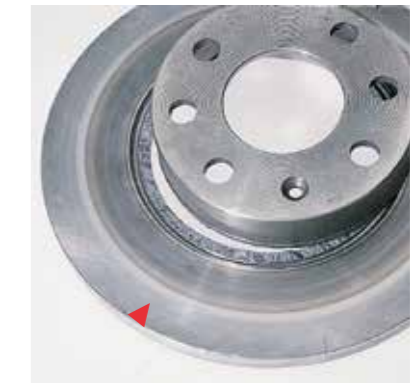
2.1.5 INCORRECT ASSEMBLY OF THE CALIPER BODY ON THE AXLE

Description of defect: The braking surfaces have broken away from the hub. Asymmetrical braking surface wear can be noted: the central area of the external surface in respect of the vehicle and the outer edge of the internal surface. In this case mechanical stress has caused the disc to break and the braking surfaces have come away. **Consequences:** The impact of this breakage can be felt when braking. Very loud rasping noises. Safety is compromised.

Advice: Before fitting new discs check the alignment and assembly of the caliper body on the axle.

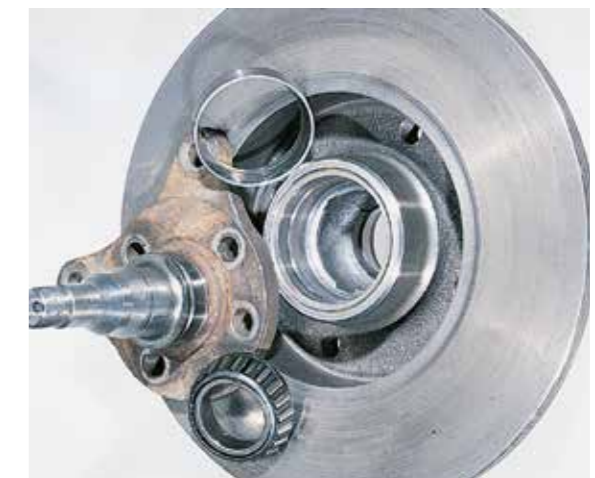
2.1.6 INCORRECT TIGHTENING OF THE DISC AND HUBBEARINGS

Description of defect: An exaggerated tightening torque knocks the bottom out of the bearing seat.

Consequences: Braking system functioning is compromised because of disc instability relative to the bearings. Strong vibrations are felt right from the first braking action.

Advice: Replace the hub, bearings and disc. Apply correct tightening torque when installing.

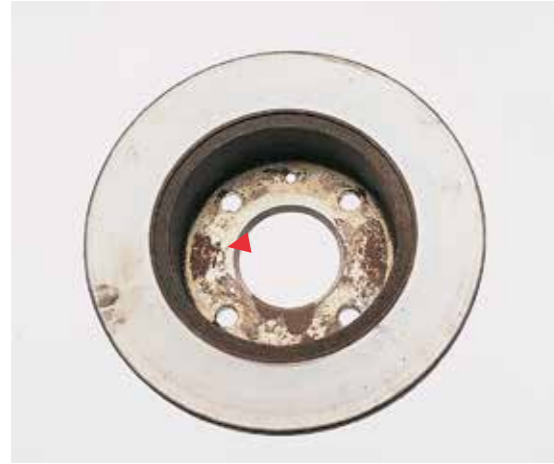
2.1.7 DIRTY HUB

Description of defect: The hub surface was not cleaned when the disc was fitted: presence of rust or dirt. Tightening against this unsuitable surface causes the new disc to run out excessively.

Consequences: This error during installation causes the onset of vibrations after a few hundred or thousand braking actions, vibrations that increase with the distance travelled. Uneven disc wear as a result of the pads causes DTV to increase - this is

the origin of the vibrations - and noise (see section 3.3.3).

Advice: Clean contact surfaces very carefully. Check disc run out after installation.

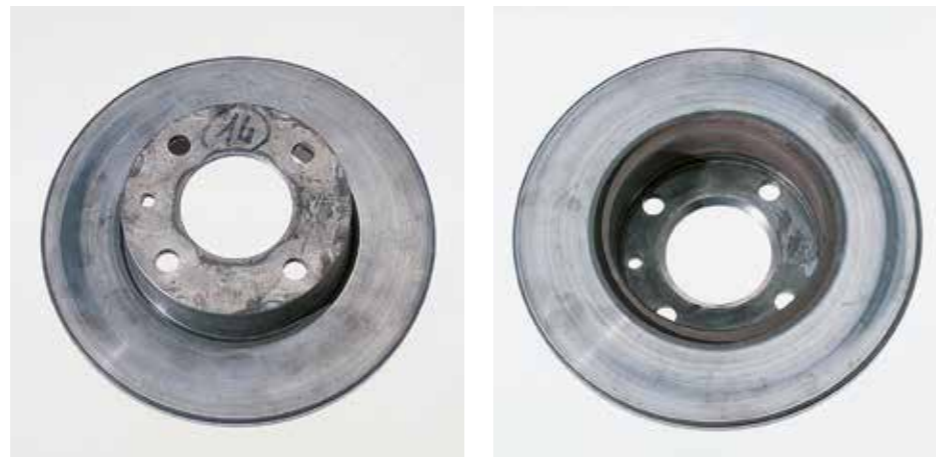
2.1.8 PRONOUNCED WHEEL HUB RUN OUT

Description of defect: Excessive hub run out causes the braking surfaces to wear as they are not parallel to the plane of the disc. Evidence of localised overheating is indicated by the darker colour of the worn areas. This is due to an alternating rubbing action of the disc and pads as a result of pronounced wheel hub run out.

Consequences: Vibrations can be felt right from the start and progressively increase. Onset of loud noises.

Advice: Check the wheel hub run out and ensure that this falls within the tolerance specified in the disc installation instructions.

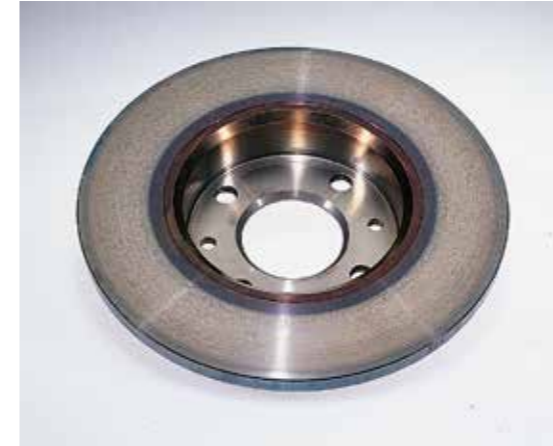
2.2.1 NO RUNNING IN

Description of defect: Disc shows colouring of varying intensity and shades (blue, violet, golden), mainly visible in the cooling areas (groove and carrier interior).

Consequences: Initial slight vibrations that progressively increase. Overheating of this type alters the mechanical characteristics of the cast iron in as much as there is a change in structure due to the formation of cementite (Fe₃C).

Advice: Always advise users to observe a running in period. Brake only moderately and briefly during the first 200-300 kilometres over a mixed itinerary. Avoid prolonged pad to disc contact.

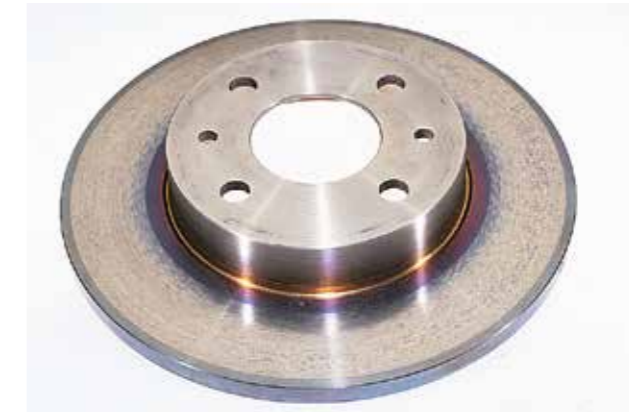
2.2.2 INTENSIVE USE

Description of defect: Disc thickness is considerably less than the recommended minimum thickness (4 mm less in total). Cracks are evident. Heat spots are visible in areas corresponding to the ventilation blades. This is advance warning that other cracks will form.

Consequences: Noises, vibrations.

Advice: This situation is typical of that found on certain sports vehicles which are subjected to an intensive and excessive use on the road.

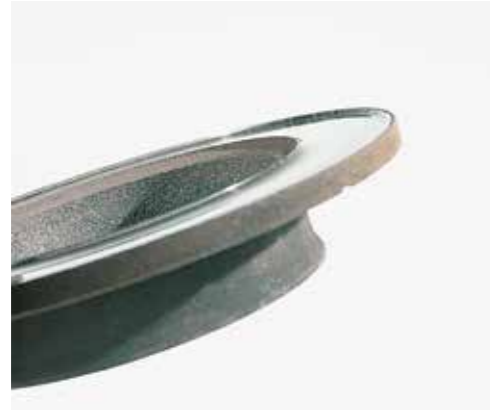
2.3.1 EXCEEDING THE LIMIT

Description of defect: The thickness of the braking surfaces measured using a micrometer is less than the recommended minimum thickness etched on the outer disc rim or on the carrier.

Consequences: Performance and comfort decreases.

Advice: Check state of disc wear periodically. The disc should be replaced after every two or three pad changes. Pads must be changed every time discs are replaced.

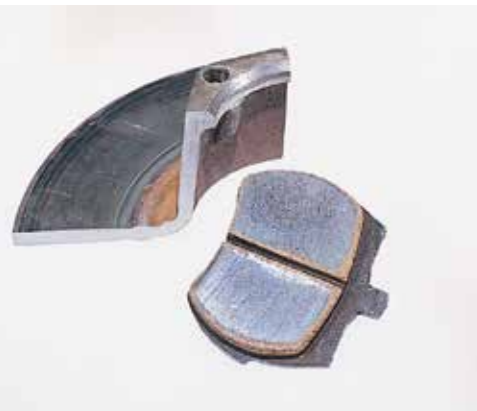
2.3.2 EXCESSIVE WEAR WITH CRACKS

The minimum thickness indicated on the outer rim of the disc has been exceeded by more than 1 mm. Furthermore, the disc has been subjected to excessive operating temperatures as a result of the reduced braking surface thickness. This causes cracks of a thermal origin.

More marked wear can be noted in the central area of the disc whereas the area in correspondence with

the pads is less worn. This can be attributed to the presence of hard points in the friction material, an indication that the production mixture was not homogeneous. It can also indicate poor functioning of the caliper.

Consequences: Distortion caused by vibrations during braking. In the long run cracks may form that can lead to disc breakage.

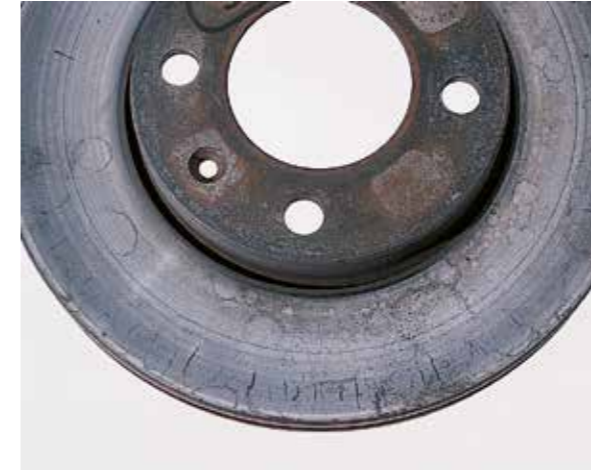
2.3.3 APPEARANCE OF CRACKS

Description of defect: The disc has been subjected to excessive operating temperatures: in the outer area of the braking surface there are evident signs of overheating. High operating temperatures lead to the appearance of cracks.

Consequences: Distortion and pad "bouncing" when hot that causes vibrations during braking. With time, cracks form and the disc may break.

Advice: The worn disc must be replaced. Check the state of wear periodically.

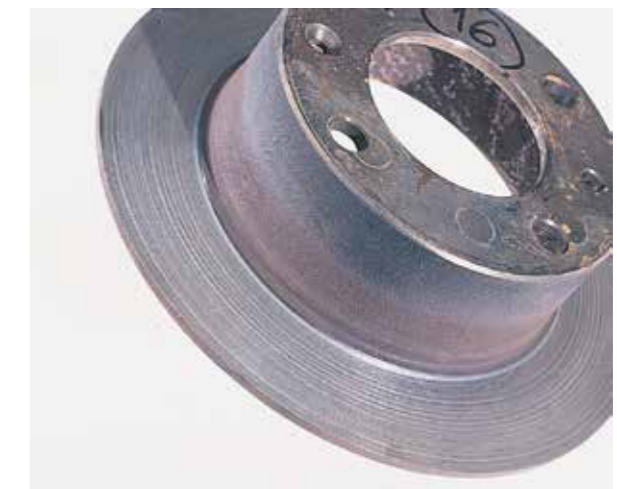
2.3.4 EXCESSIVE WEAR AND PADS COMPLETELY WORN DOWN

Description of defect: The disc is extremely worn and has been damaged by the metal pad support, the friction material of which has completely disappeared. The thickness of this disc when new was 7 mm, measured now it is 3.5 mm compared to a recommended minimum thickness of 5 mm.

Consequences: Very loud noises, very long braking distances, caliper functioning is critical.

Advice: Replace pads when they reach wear limits. Check out the pad wear warning indicator circuit.

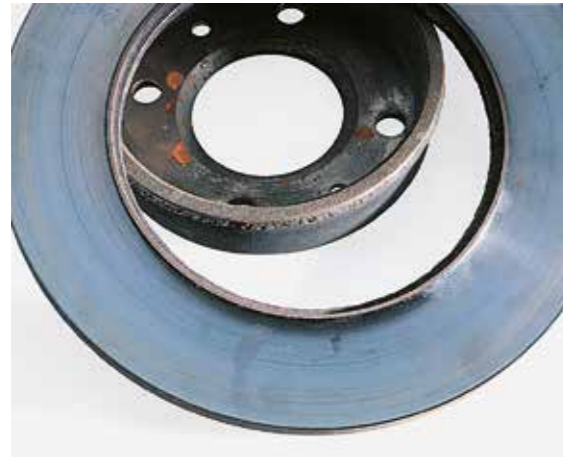
2.3.5 BREAKAGE DUE TO EXCESSIVE WEAR

Description of defect: Braking surfaces show evident signs of overheating due to the considerably reduced mass of the worn disc. This situation has caused the braking surfaces to break away from the hub.

Consequences: Violent impact during braking. A very strong rasping noise when braking. Possible safety problem.

Advice: Always check the disc thickness every time the pads are replaced. Replace the disc before it reaches its wear limit.

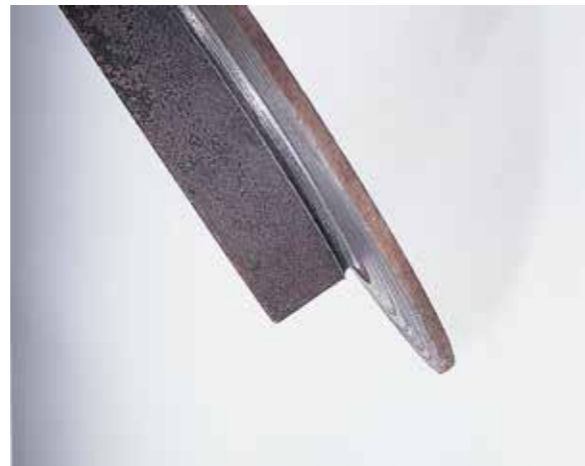
2.3.6 EXCESSIVE PAD WEAR AND MOVEMENT OF THE SUPPORT

Description of defect: Disc thickness less than the limit value. The disc has been worn by the pad support as friction material is completely absent. The metal support plate has come out of its seat in the caliper and has almost entirely cut the disc brake surface from the carrier. The braking surfaces are near to breaking away from the carrier.

Consequences: Rasping noises, loss of efficiency (considerable brake pedal slack), possible rubbing between the disc and caliper, thrust of the caliper is not symmetrical.

Advice: Check and, if necessary, repair the caliper. Replace the discs and pads.

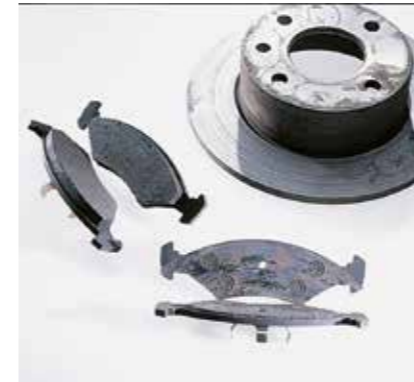
2.4.1 UNEVEN WEAR OF VARIOUS PARTS

Description of defect: A braking surface of one of the discs is in contact with the metal pad support. Examining the pads it is noted that wear is uneven due to blocking of the caliper (the pads on the other caliper are in perfect condition).

Consequences: The caliper's two pads are completely worn down with consequent onset of noises and vibrations, the brake pedal has to be depressed completely. Braking distance is very long.

Advice: Check, repair or replace the caliper. Replace all discs and pads.

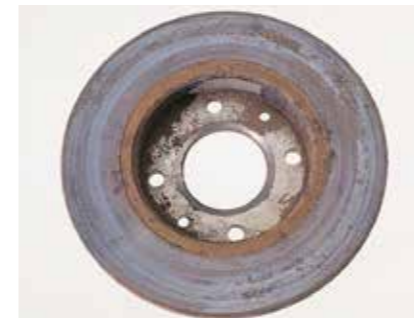
2.4.2 VITRIFIED DISC

Description of defect: Presence of a very fine deposit of friction material on the disc surface which now has a shiny finish (corrosion has then caused the detachment of part of this layer).

Consequences: Loss of braking efficiency, braking distances too long. The pedal is very stiff but with no braking action.

Advice: Replace discs and pads. Use high, original, quality pads.

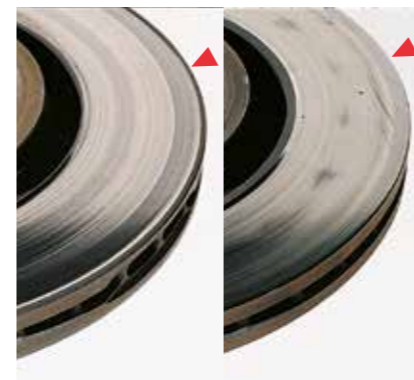
2.4.3 UNEVEN BRAKING SURFACE WEAR

Description of defect: The two pads were not positioned in the same manner with respect to the disc. Wear has not been the same for both surfaces. Heat spots can be noted at the centre of the braking surface due to high thermal exposure. The caliper and/or the pads were not fitted properly.

Consequences: Gradual onset of vibrations due to the heat spots. Possible appearance of cracks.

Advice: Check and, if necessary, repair the calipers. Check the pad model and friction material quality.

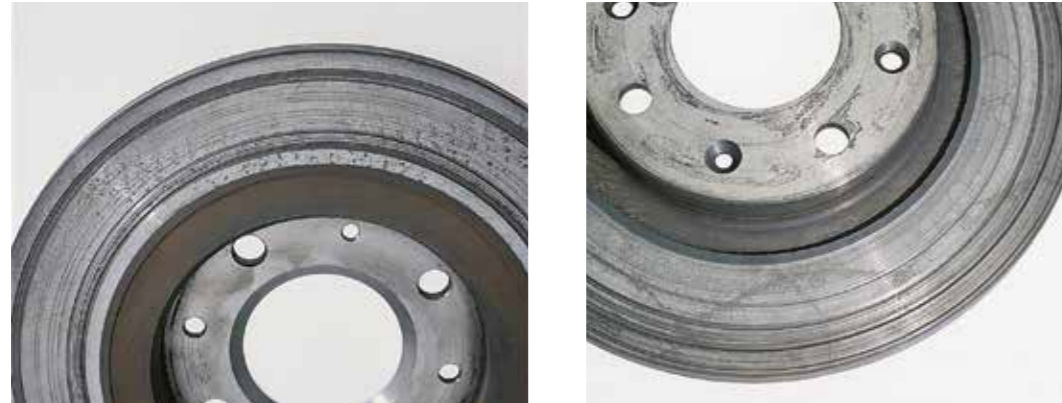
2.4.4 DEEP GROOVES AND SCORING

Description of defect: Deep scores caused by penetration of foreign bodies between pads and disc can be noted. This can be due to unsuitable pad material or the presence of badly distributed abrasives in the mixture.

Consequences: Very unpleasant noise both during braking and when travelling. Diminished efficiency as a result of the reduced contact surface between disc and pads.

Advice: Replace discs and pads.

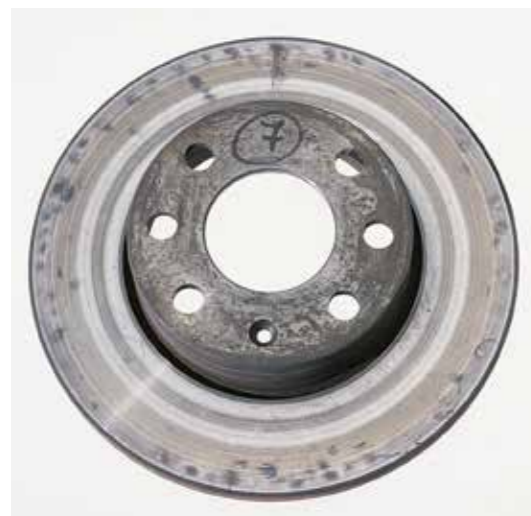
2.4.5 FRICTION MATERIAL DEPOSITS

Description of defect: The braking surfaces are completely covered by very dark spots. These spots are due to deposits of pad friction material. This causes overheating which in turn leads to a transformation of the cast iron with the formation of very hard cementite. **Consequences:** Onset of vibrations that become progressively worse.

Advice: Only install friction material that is suited to the brake and vehicle.

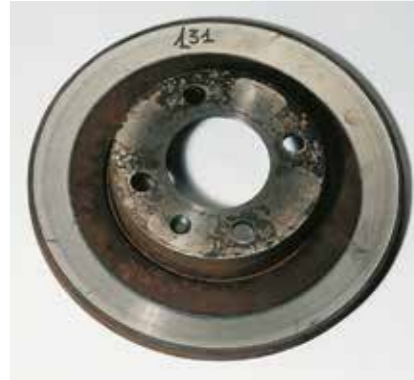
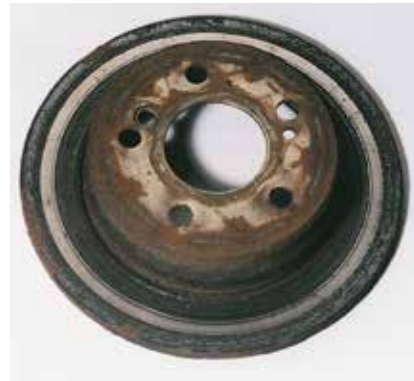
2.4.6 BRAKING SURFACES PARTLY WORN BY THE PADS

Description of defect: The braking surface only shows wear in the outer area. The inner area never comes into contact with the pads as indicated by the presence of corrosion (rust). This situation could be caused by:

- incorrect installation of the caliper and hence the pad which does not make full contact with the disc
- loss of part of the friction material
- fitting of wrong pads

Consequences: Reduced braking torque. Increase in operating temperature as the surface on which the pad works is reduced (by about 50% in this example) compared to its normal working surface. There is a risk of localised overheating and therefore the onset of hot judder-type vibrations. Moreover, reduced system efficiency leads to high stress levels and therefore rapid and/or uneven wear (cold judder).

Advice: check the installation and correct functioning of the caliper. Check the fitting and condition of the pads. Check that the pad model is suitable for the particular vehicle.

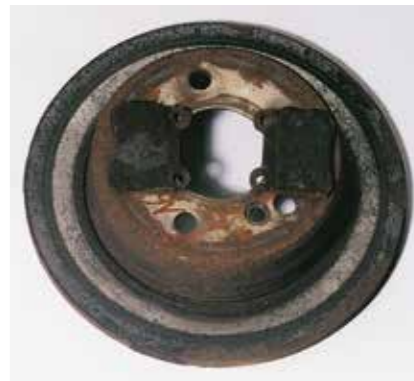
2.4.7 PARTIALLY WORN AND VITRIFIED BRAKING SURFACES

Description of defect: This disc shows a deterioration that is the sum of defects described in 4.4.2 and 4.4.6 above. In this case the pad only acts on the inner section of the braking surface. High stress has led to overheating, vitrification (deposit) and detachment of friction material.

Consequences: Progressive reduction in efficiency of the system and, when friction material detaches, total inefficiency of the system.

Advice: As for 4.4.2 and 4.4.6.
