THE **BREMBO** GUIDE
TO **BRAKE DISC**
ASSEMBLY AND
MAINTENANCE

Curno, September 15, 1997

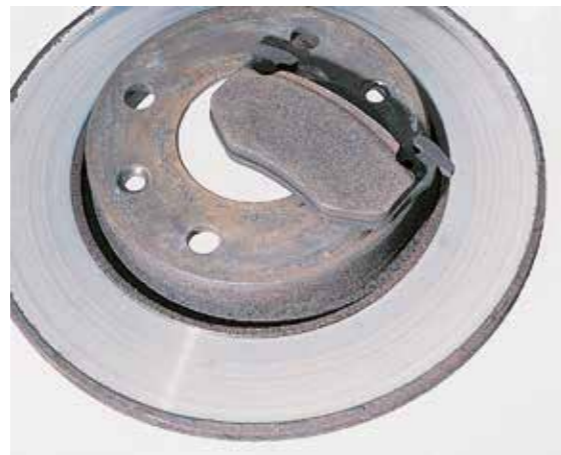
The second case is exceptional, rather extreme. Careful examination of the state of the disc and pads reveals visible defects and is always a valuable source of information as to the overall functioning of the system. It can be seen in the photo that a foreign body (a screw) is lodged between the disc and pad, it probably happened during refitting. The illustration shows the damage that this piece of steel can provoke, damaging the disc and causing unusual wear, a source of vibrations and noise when braking.

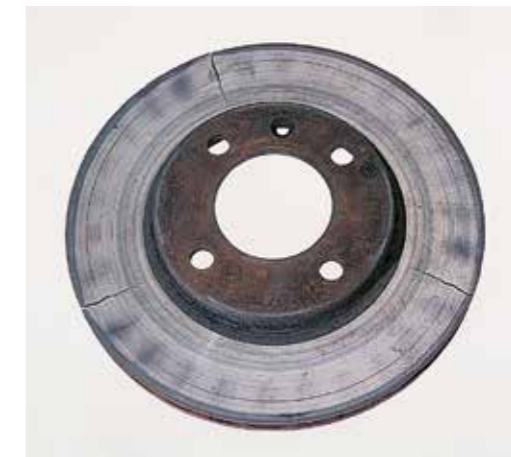
2.3.1 EXCEEDING THE LIMIT

Description of defect: The thickness of the braking surfaces measured using a micrometer is less than the recommended minimum thickness etched on the outer disc rim or on the carrier.

Advice: Check state of disc wear periodically. The disc should be replaced after every two or three pad changes. Pads must be changed every time discs are replaced.

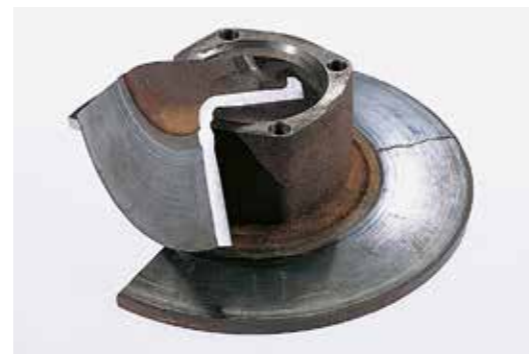
2.3.3 APPEARANCE OF CRACKS

Description of defect: The disc has been subjected to excessive operating temperatures: in the outer area of the braking surface there are evident signs of overheating. High operating temperatures lead to the appearance of cracks.

Consequences: Distortion and pad "bouncing" when hot that causes vibrations during braking. With time, cracks form and the disc may break.

Advice: The worn disc must be replaced. Check the state of wear periodically.
